National Park Service			MULTLIST = SDAS For NPS use only		
National Register of Historic Places Inventory—Nomination Form			received date entered		
ons in How to Completes—complete applica	ete National Register Forms ble sections				
ne					
y National Bank E	Building				
Langford Buildi	ing				
ation					
er 121 S. E. 1st	Street		not for publication		
Miami	vicinity of				
Florida 33131	code FL county	Dade	code FL 025		
ssification					
both Public Acquisition in process	X yes: restricted	Present Use agriculture commercial educational entertainmen government industrial military	museum park private residence religious scientific transportation other:		
er of Prop	erty				
n S. Braslow					
121 S. E. 1st S	treet, Suite 802				
Miami	vicinity of		nte Florida 33131		
ation of Le	gal Descripti	on			
stry of deeds, etc. D	ade County Courthouse				
	5 W. Flagler Street				
м	iami	sta	te Florida 33130		
		Surveys

Section number 7 Page 1 City National Bank Building

Section number 8 Page 1 City National Bank Building

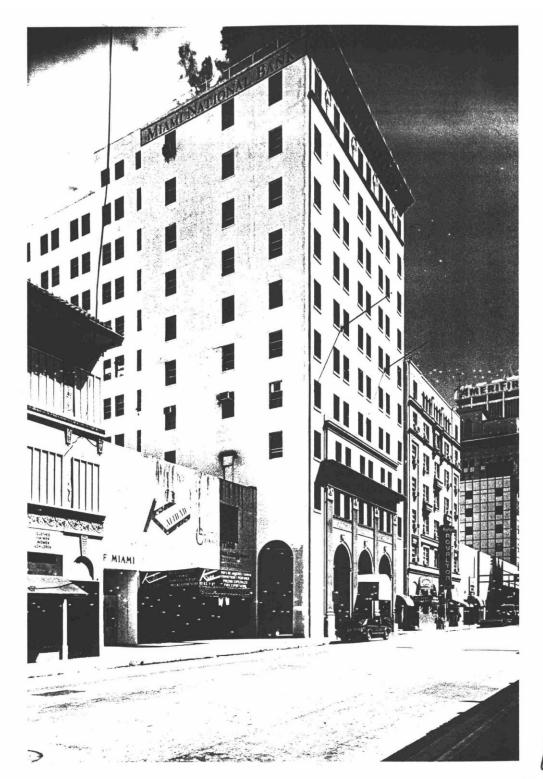
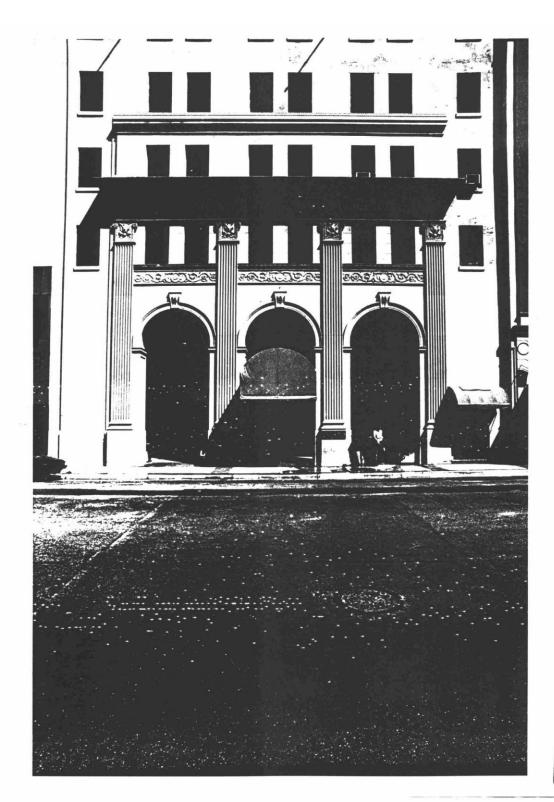
CITY NATIONAL BANK BUILDING

121 S.E. 1 STREET
